Manhole Inspection Summary

Manhole # S39U1_005MH

Insp Date: **5/30/08 11:46 AM**

Location Address: **326 Maude Ave**

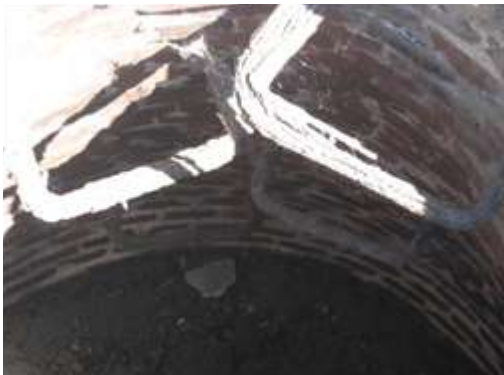
Steps

Count: **4** Missing: **0** ☒ **Corroded**

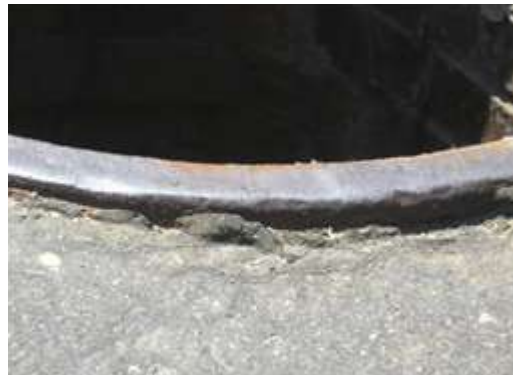
Defect 1

Offset: **0.5** (in.)

Frame above the grade.

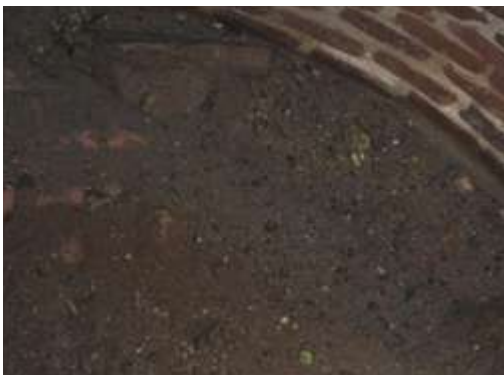
Defect 2

Bench covered with debris.

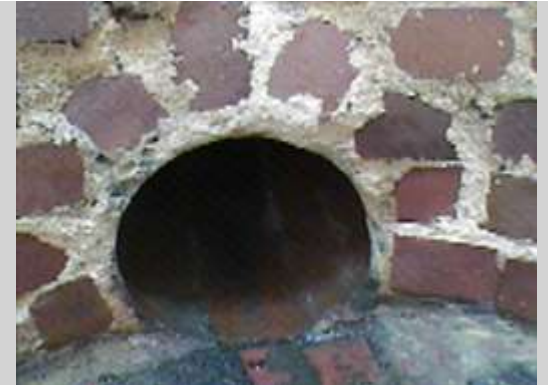
12 O'Clock Outflow

8 in. Circular Gravity Sewer
Pipe Out @ 12 O'Clock

Infiltration: **None** Pipe Seal Cond: **Sound**
